Case Study: MnDOT Asphalt Testing Lab

INTRODUCTION

The Maplewood MnDOT testing facility was originally constructed in 1988. There have been several upgrades and modifications occurring due to changes in facility requirements in the areas within this case study which included the Asphalt (Binders) Lab-94 and Analytical Lab-99.

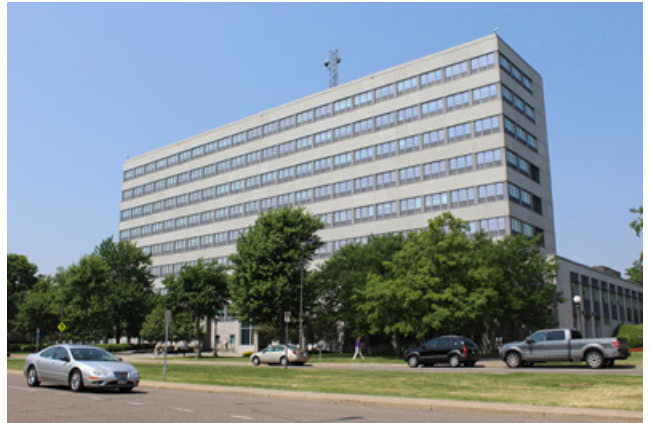
The OA temperature installation needs to be looked at. Throughout testing it was observed that the OA conditions reported on the BAS did not match the actual conditions. During gathering information for this final report, it was observed that the OAT indicated >90F with actual temperatures in the low 80s as reported by the national weather service. This effect on all systems using OAT to reset temperatures causes improper control of the economizer modes and the temperature resets based on OA conditions. It was recommended that only 2 sensors be installed at this facility, one as primary with a redundant back up in case of failure.
